Comparative Degradation of PVC Sewer Pipes in Sudan and Saudi Arabia: Influence of Dietary-Driven Wastewater Composition

Abstract—Polyvinyl chloride (PVC) sewer pipes are widely used in both Sudan and Saudi Arabia, but their operational lifetimes are affected by wastewater composition, which in turn is shaped by local dietary habits. This study evaluates how varying levels of fats, oils, grease (FOG), suspended solids (TSS), and disinfectants influence the chemical, mechanical, and surface degradation of PVC pipes. Field samples of wastewater and aged PVC pipe segments were collected from residential and commercial zones in both countries. Laboratory analyses included BOD₅, COD, FOG, pH, TSS measurements; surface characterization with SEM and FTIR; tensile strength and thermal stability (DSC) tests. We observe that Saudi wastewater, which has higher FOG, induces more surface softening, lipid residue accumulation, and tensile strength loss (~25-35%), whereas Sudan samples have increased abrasive wear and micro-cracking, down to 10-20% strength loss. The results underline that dietary habits and wastewater management practices must inform PVC pipe material selection and maintenance

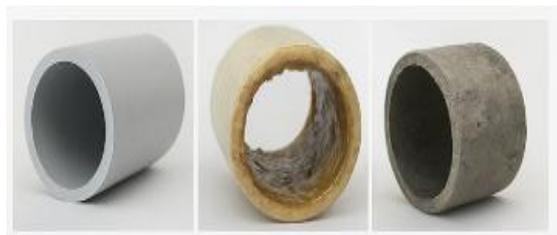
Figure 2.:FOG: 1700mg/L TSS: 620m Figure 3. Saudi Sudan Sample

To complement the laboratory analyses, visual inspection of the collected PVC pipe segments was performed. Representative photographs of new (unused) and aged pipes from both Sudan and Saudi Arabia are presented in Figure X. These images provide direct evidence of surface-level degradation processes. The Saudi samples exhibit visible greasy layers and surface softening attributed to high FOG loads, while the Sudanese samples show roughened surfaces and microcracking, consistent with abrasive wear from high TSS concentrations. Such photographic comparisons serve as a baseline reference before advanced characterization using SEM, FTIR, and DSC.

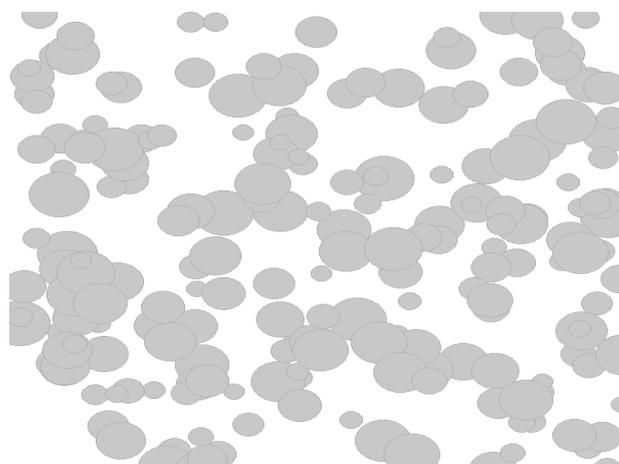
SEM micrographs illustrate differences in surface morphology. Saudi samples (Figure 3) reveal a greasy film layer with microbubbles indicating lipid deposition and surface softening. In contrast, Sudanese samples (Figure 3) show roughened surfaces and microcracking, consistent with abrasive wear from high TSS concentrations.

Figure 4. SEM image of Saudi PVC pipe surface, showing greasy deposits and microbubbles.

In Saudi Arabia, high FOG levels paired with relatively stable alkaline pH and moderate temperatures foster conditions for lipid adherence, oxidation, and softening of PVC surface and reduction in mechanical strength. In Sudan, lower FOG but higher solid loading (TSS) and more pH fluctuations lead to mechanical wear and micro-cracking rather than deep chemical attack.

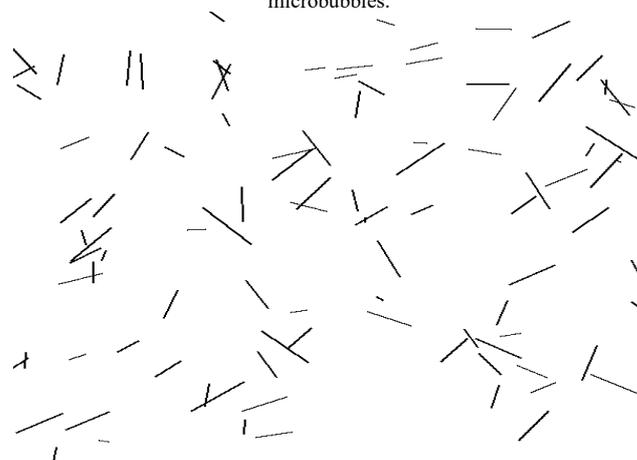
show rougher surfaces with microcracks and evidence of abrasive wear due to high suspended solids.

Figure 5. SEM image of Sudan PVC pipe surface, showing microcracks and abrasion marks.

These distinctions imply that mitigation strategies must be tailored: grease traps and regular descaling are essential in high FOG contexts; abrasion resistant PVC formulations (fillers, stabilizers), protective coatings, or more frequent inspections where solids loads are high.

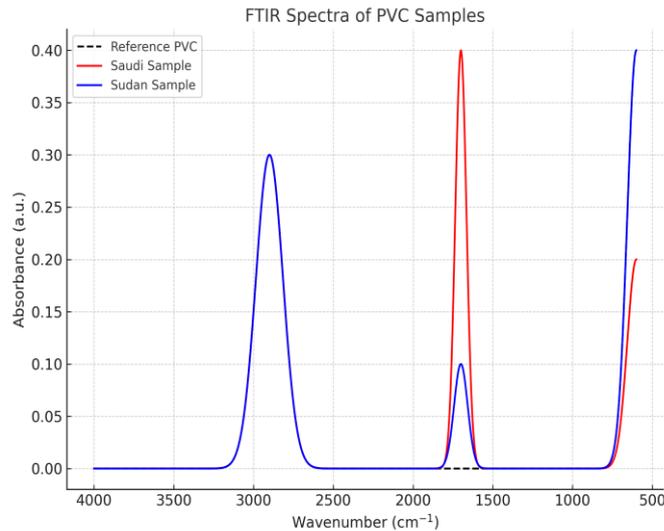
FTIR spectra (Figure 4) confirm these observations: Saudi pipes showed significant carbonyl (C=O) and ester peaks around 1700–1735 cm^{-1} , along with reduced C–Cl stretching, indicating chemical oxidation and lipid adherence. Sudanese samples only displayed minor oxidation signals.

Figure 6. FTIR spectra of PVC pipes. Saudi samples show strong carbonyl peaks and reduced C–Cl intensity, while Sudanese samples show minor oxidation.

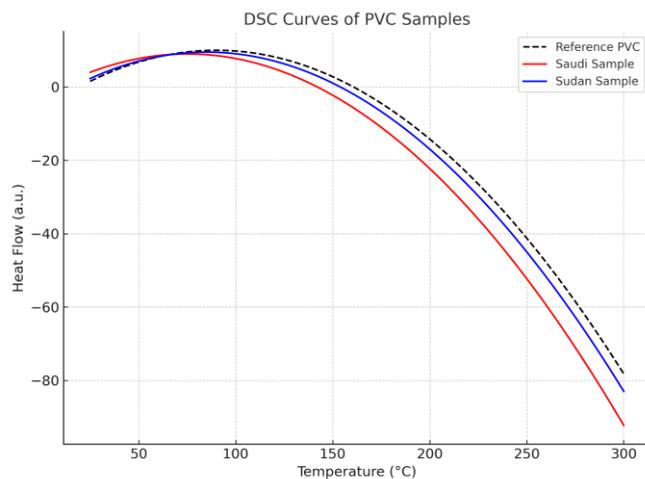
DSC results (Figure 7) highlight thermal stability differences. Saudi samples exhibited earlier decomposition onset and lower glass transition temperature (T_g), consistent with chemical softening caused by FOG. Sudanese samples showed smaller shifts in T_g and decomposition, reflecting that their degradation is dominated by mechanical abrasion rather than chemical attack.

Figure 7. DSC curves of PVC pipes. Saudi samples exhibit earlier onset of thermal degradation and lowered T_g , while Sudanese samples show minor shifts.
